Subj: HMMT-302 AAR ser 1-69A concerning CH-46D BuNo 153343 accident
occurring 2 July 1968, pilot BAGWELL

NAVSAFECEN INVESTIGATION 1-69

SUBJECT: CH-46D Accident of Aircraft S/N 153343. Metallurgical Investigation of Failed Rotor Blade, P/N A02R1502, S/N A-2-668.

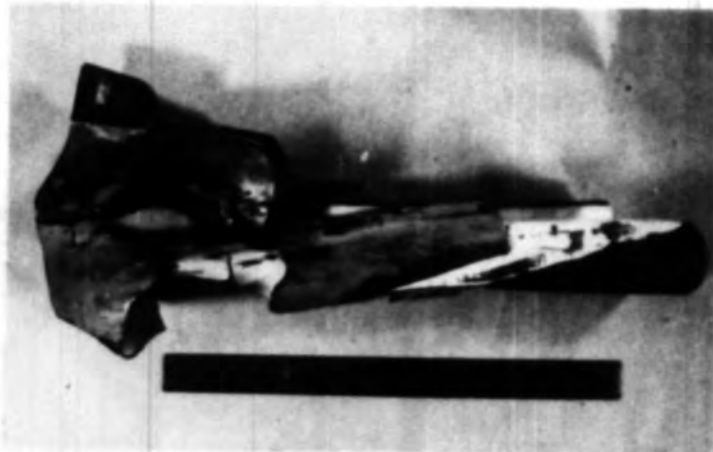
FIGURE 3 .23X
AS RECEIVED OUTBOARD SEGMENT OF
THE AFT ROTOR BLADE P/N A02R1502,
S/N A-2-668. VIEW SHOWS LEADING
EDGE AND TOPSIDE.

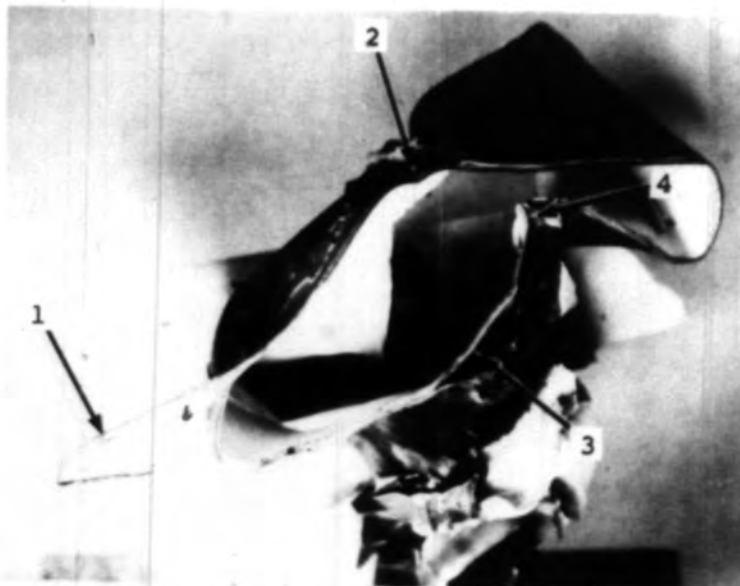
1. A 3 foot long spanwise segment containing the inboard fracture surface (Figures 1, 2, & 7). Failure occurred at blade station 24, which corresponds to 83.8 per cent of the radius.
2. The second segment was an 18 inch long spanwise section containing the outboard fracture surface. This segment was severely deformed due to apparent impact at the leading edge (Figures 3, 4, 5, and 6).

FIGURE 6 .6X
OUTBOARD SEGMENT VIEW SHOWS THE
FRACTURE SURFACE. ARROW 1 INDI-
CATES THE ORIGIN. ARROW 2 INDI-
CATES THE SPAR NOSE. ARROWS 3
AND 4 INDICATE THE HEEL AREA.

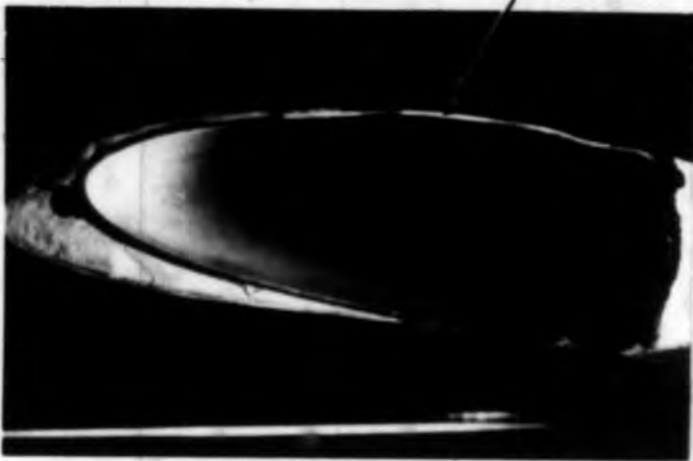
Examination of the fracture surfaces revealed a fatigue mode of failure. Propagation initiated below the surface from a semi-circular origin located on the top outer surface of the spar, approximately 2.00 inches from the heel radius (Figure 7).

FIGURE 7 .65X
INBOARD SEGMENT - VIEW SHOWS THE
FRACTURE SURFACE. THE ARROW
INDICATES THE ORIGIN ON THE TOP
SURFACE OF THE SPAR 2 INCHES
FORWARD OF THE UPPER HEEL RADIUS.

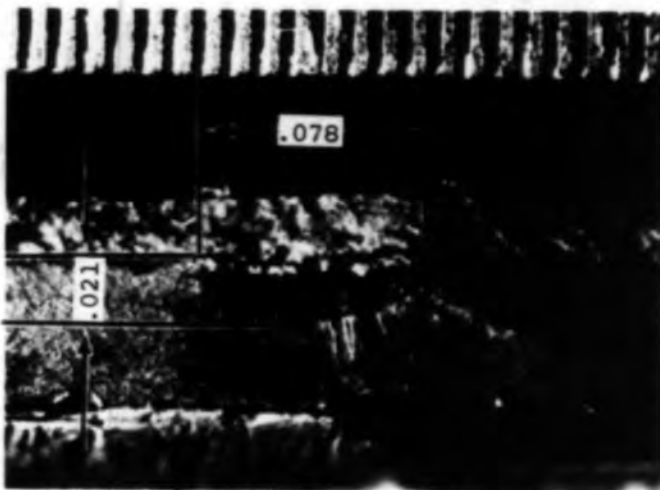
(Figure 8) and was oriented at approximately 10 degrees from the chordwise plane (Figure 9). The fracture surface in the origin area sloped at approximately 30 degrees from the top surface of the spar (Figure 10).

- B. The fracture originated from a lap at 83.8 per cent of the blade radius.
- C. The semi-circular origin was a lap oriented at a plane which intersected the top surface at an angle of 30 degrees. The lap which extended .078 inch was oriented 10 degrees from the chordwise plane. The depth of the lap was .021 inch.

FIGURE 8 18X
MAGNIFIED VIEW OF THE ORIGIN IN
THE OUTBOARD SEGMENT OF THE SPAR--
THE SEMI-CIRCULAR ORIGIN IS A LAP
MEASURING .078 INCH LONG AND .021
INCH DEEP.

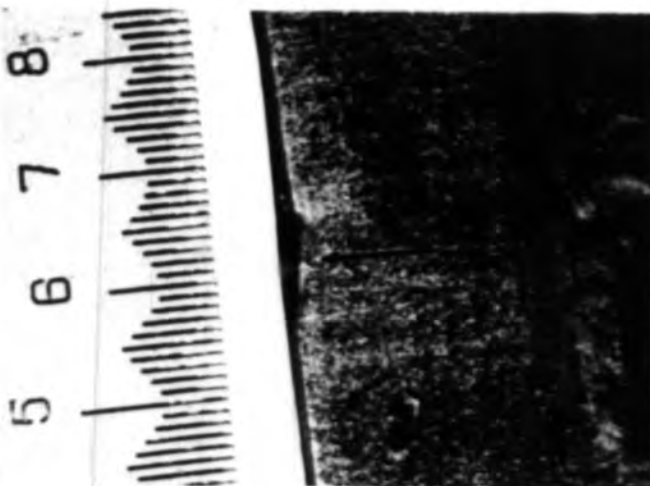
After removing the zinc plate from the outer surface of the spar in the vicinity of the origin, no evidence of surface damage was apparent (Figure 9).

FIGURE 9 7.5X
VIEW OF THE ORIGIN IN THE OUT-
BOARD SEGMENT OF THE SPAR. VIEW
SHOWS THE OUTER SURFACE STRIPPED
OF THE ZINC PLATE. NO EVIDENCE
OF SURFACE DAMAGE WAS NOTED.

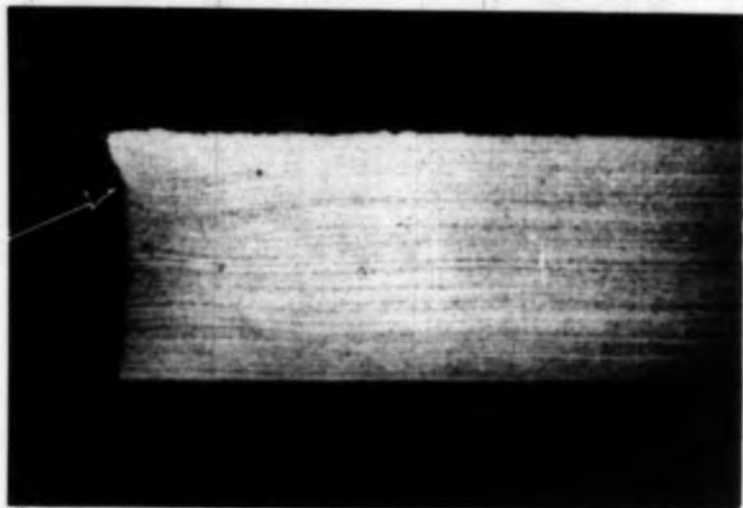
A longitudinal section of the spar wall through the origin confirmed the presence of a lap. Grain flow disturbance was evident throughout the thickness of the wall (Figure 10 - 11). A normal spar microstructure of hardened and tempered martensite was found in this section (Figure 12). No complete decarburization was noted and the partial decarburization was nil.

FIGURE 10: 30X
PHOTOMICROGRAPH OF A LONGITUDINAL
SECTION OF THE SPAR WALL AT THE
ORIGIN (ARROW) EXHIBITING DISTURBED
GRAIN FLOW.

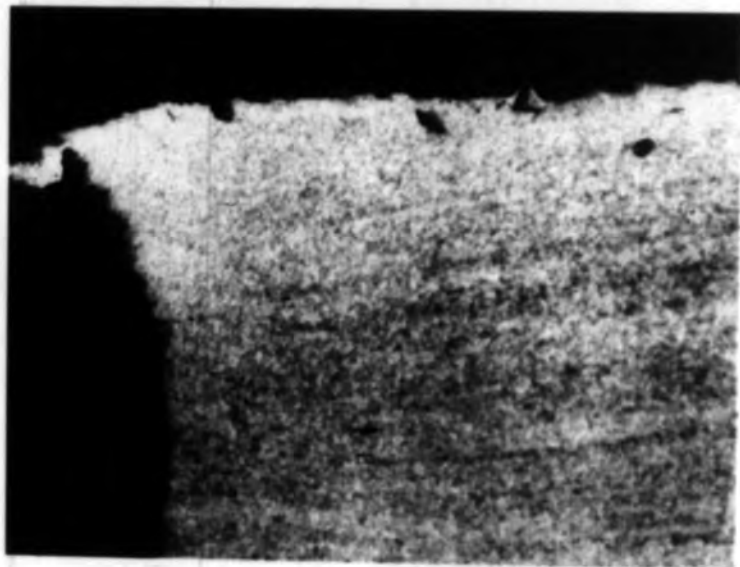
- D. Microscopic examination of a longitudinal section through the origin disclosed a grain flow disturbance throughout the cross-section.
- E. The origin was dimensionally inspected for wall thickness and found to be within the drawing tolerances.

FIGURE 11 100X
CLOSE-UP OF DISTURBED GRAIN FLOW
RESULTING FROM LAP.

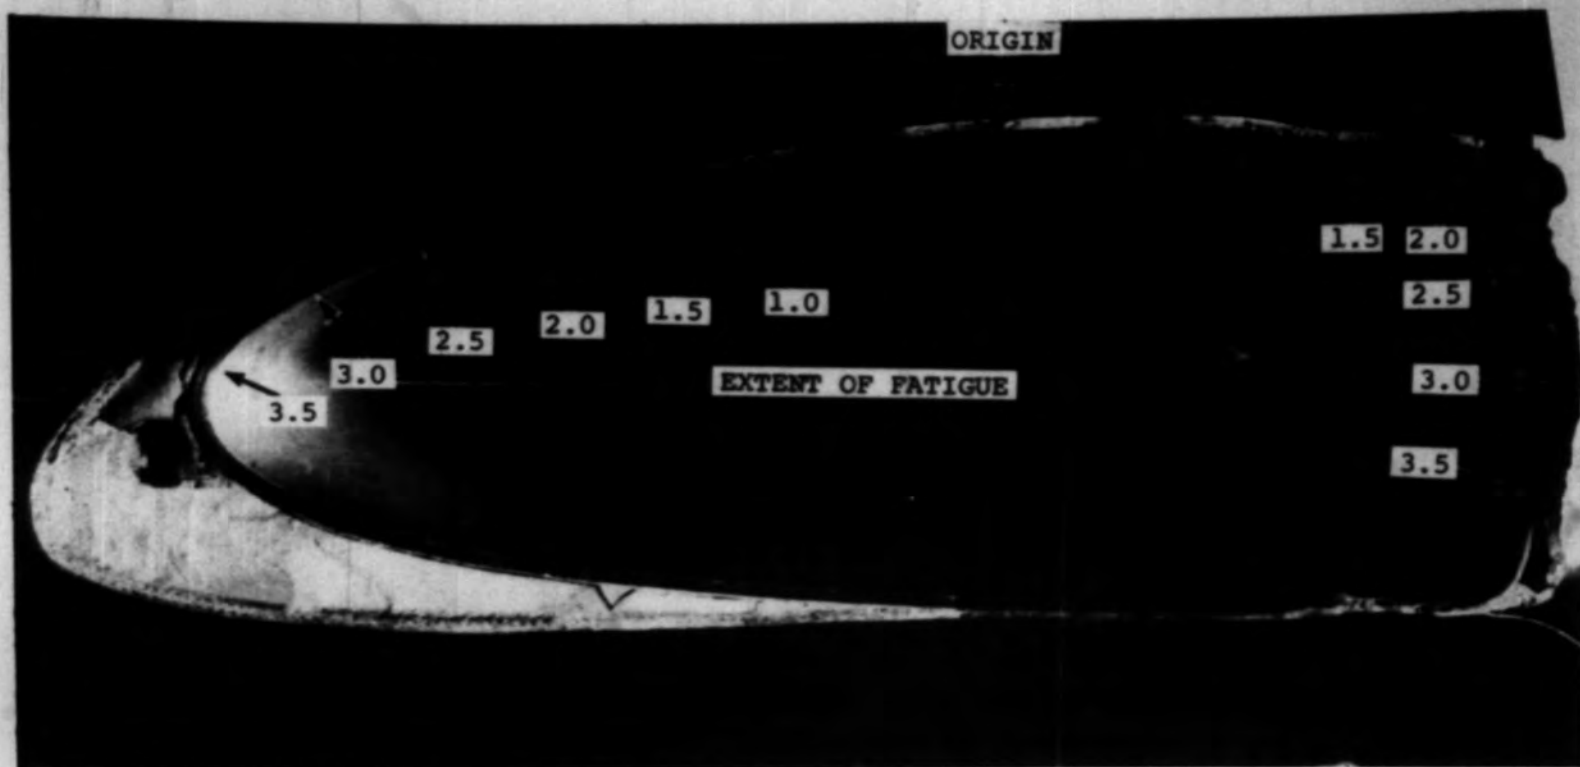
Electron fractography was used to verify the location of the transition zone from fatigue to ultimate failure. Examination of the fractographs confirmed the macroscopic evaluation. The fatigue propagation extended 3 inches forward and 3 inches aft of the origin (Figure 13). Fractographs from 11 locations are shown in Figures 14 through 25.

FRACTURE SURFACE SHOWING AREA ZONES REPLICATED FOR ELECTRON FRACTOGRAPHIC EXAMINATION.

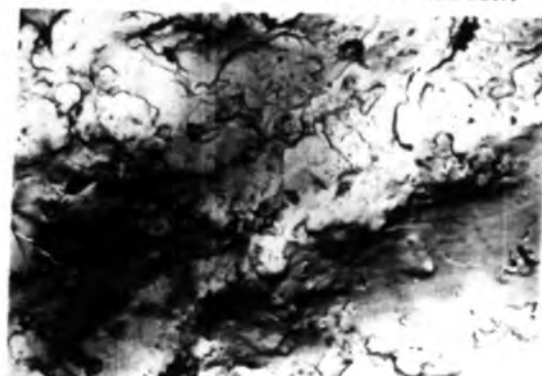
FIGURE 15 3,200X
PREDOMINANTLY FATIGUE ZONE 1.5 INCH
FORWARD OF ORIGIN.

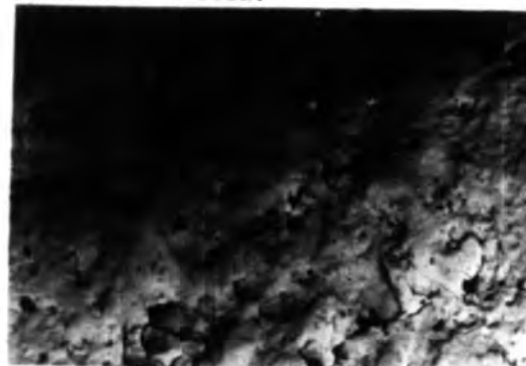
FIGURE 17 3,200X
FATIGUE ZONE 2.5 INCHES FWD OF ORIGIN.

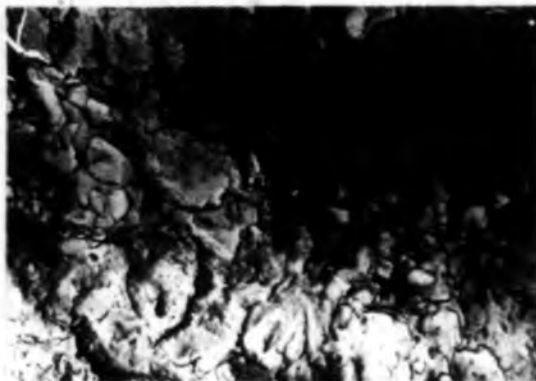
FIGURE 20 3,200X
FATIGUE ZONE 1.5 INCHES APT OF ORIGIN.

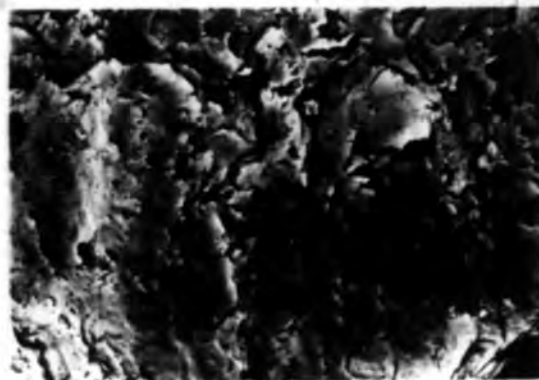
FIGURE 21 3,200X
FATIGUE AND CORROSION ZONE 2.0 INCHES
APT OF ORIGIN.

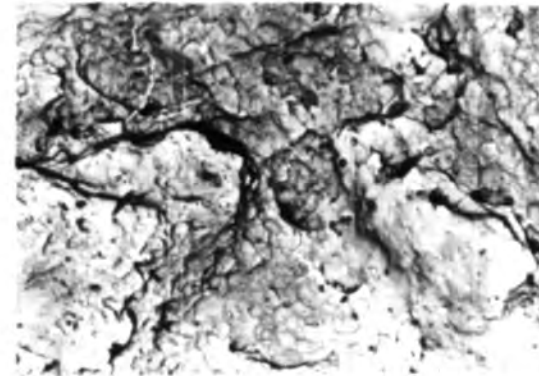
FIGURE 25 3,200X
TENSILE OVERLOAD ZONE 3.0 INCHES
APT OF ORIGIN.

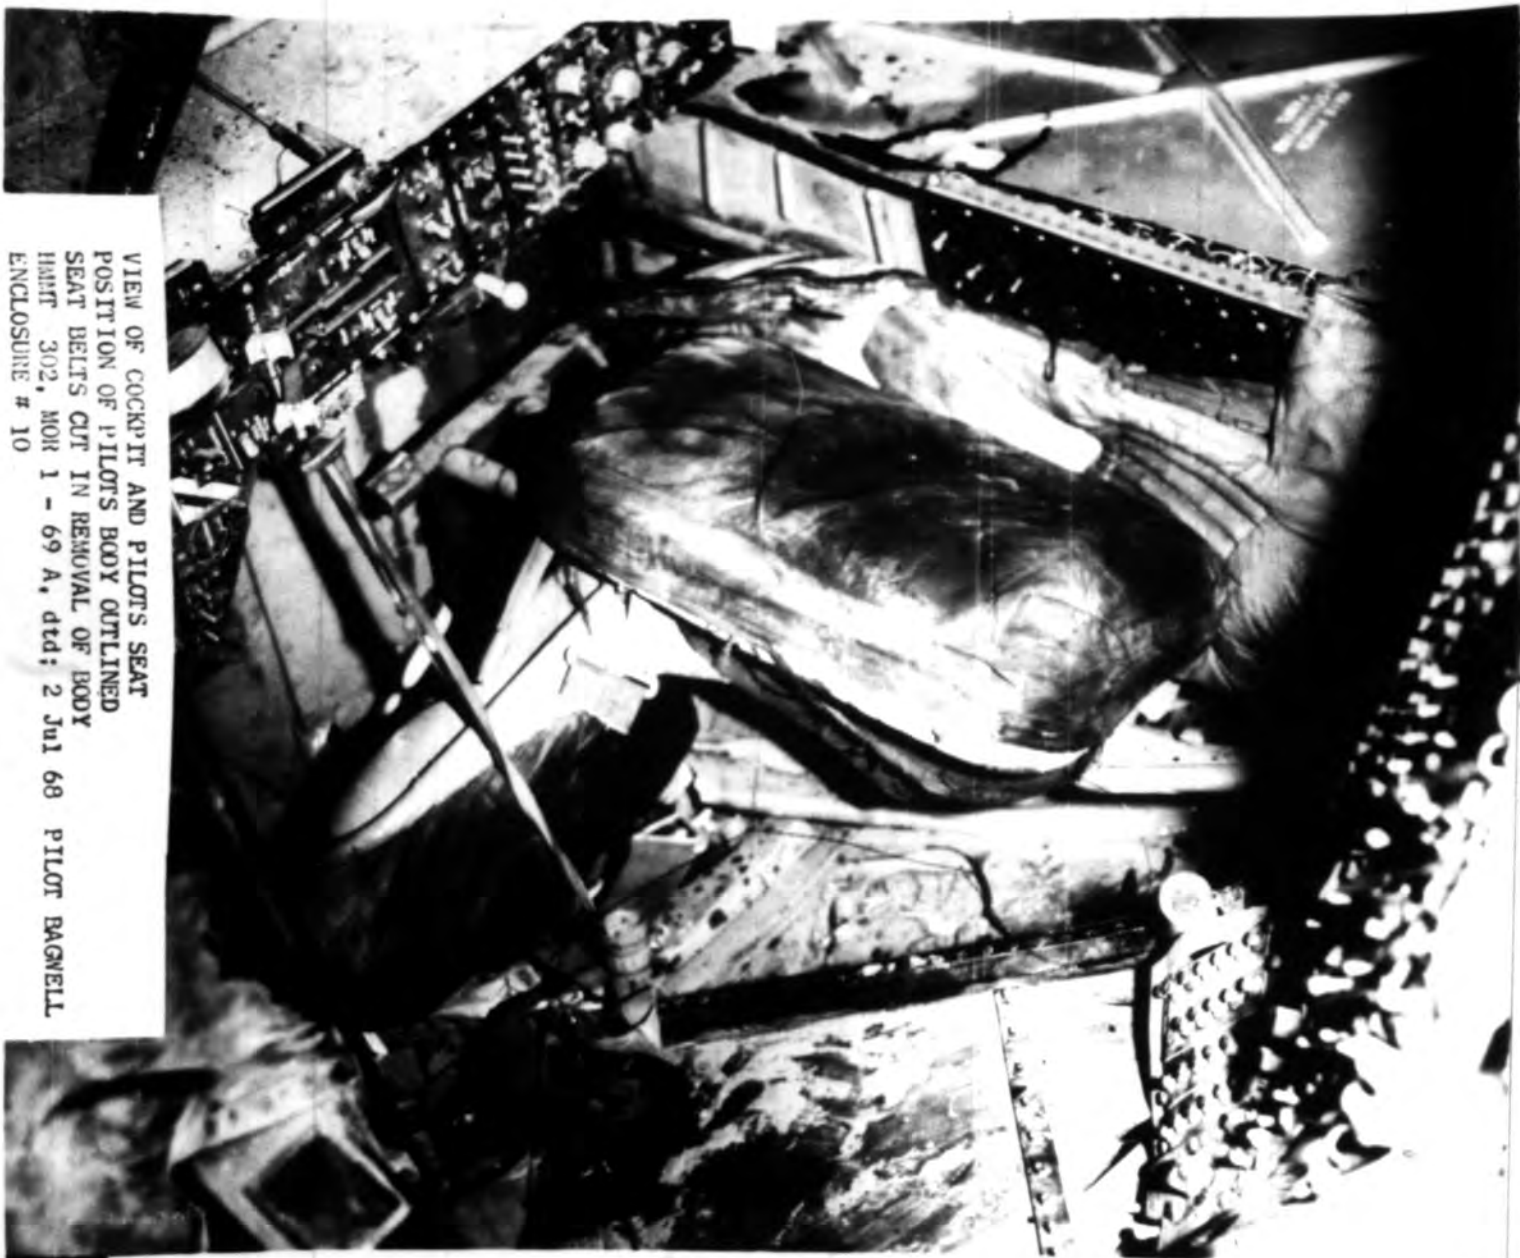
VIEW OF COCKPIT AND PILOT'S SEAT
POSITION OF PILOT'S BODY OUTLINED
SEAT BELTS CUT IN REMOVAL OF BODY
HMMT 302, MOR 1 - 69 A, dtd: 2 Jul 68 PILOT BAGWELL
ENCLOSURE # 10

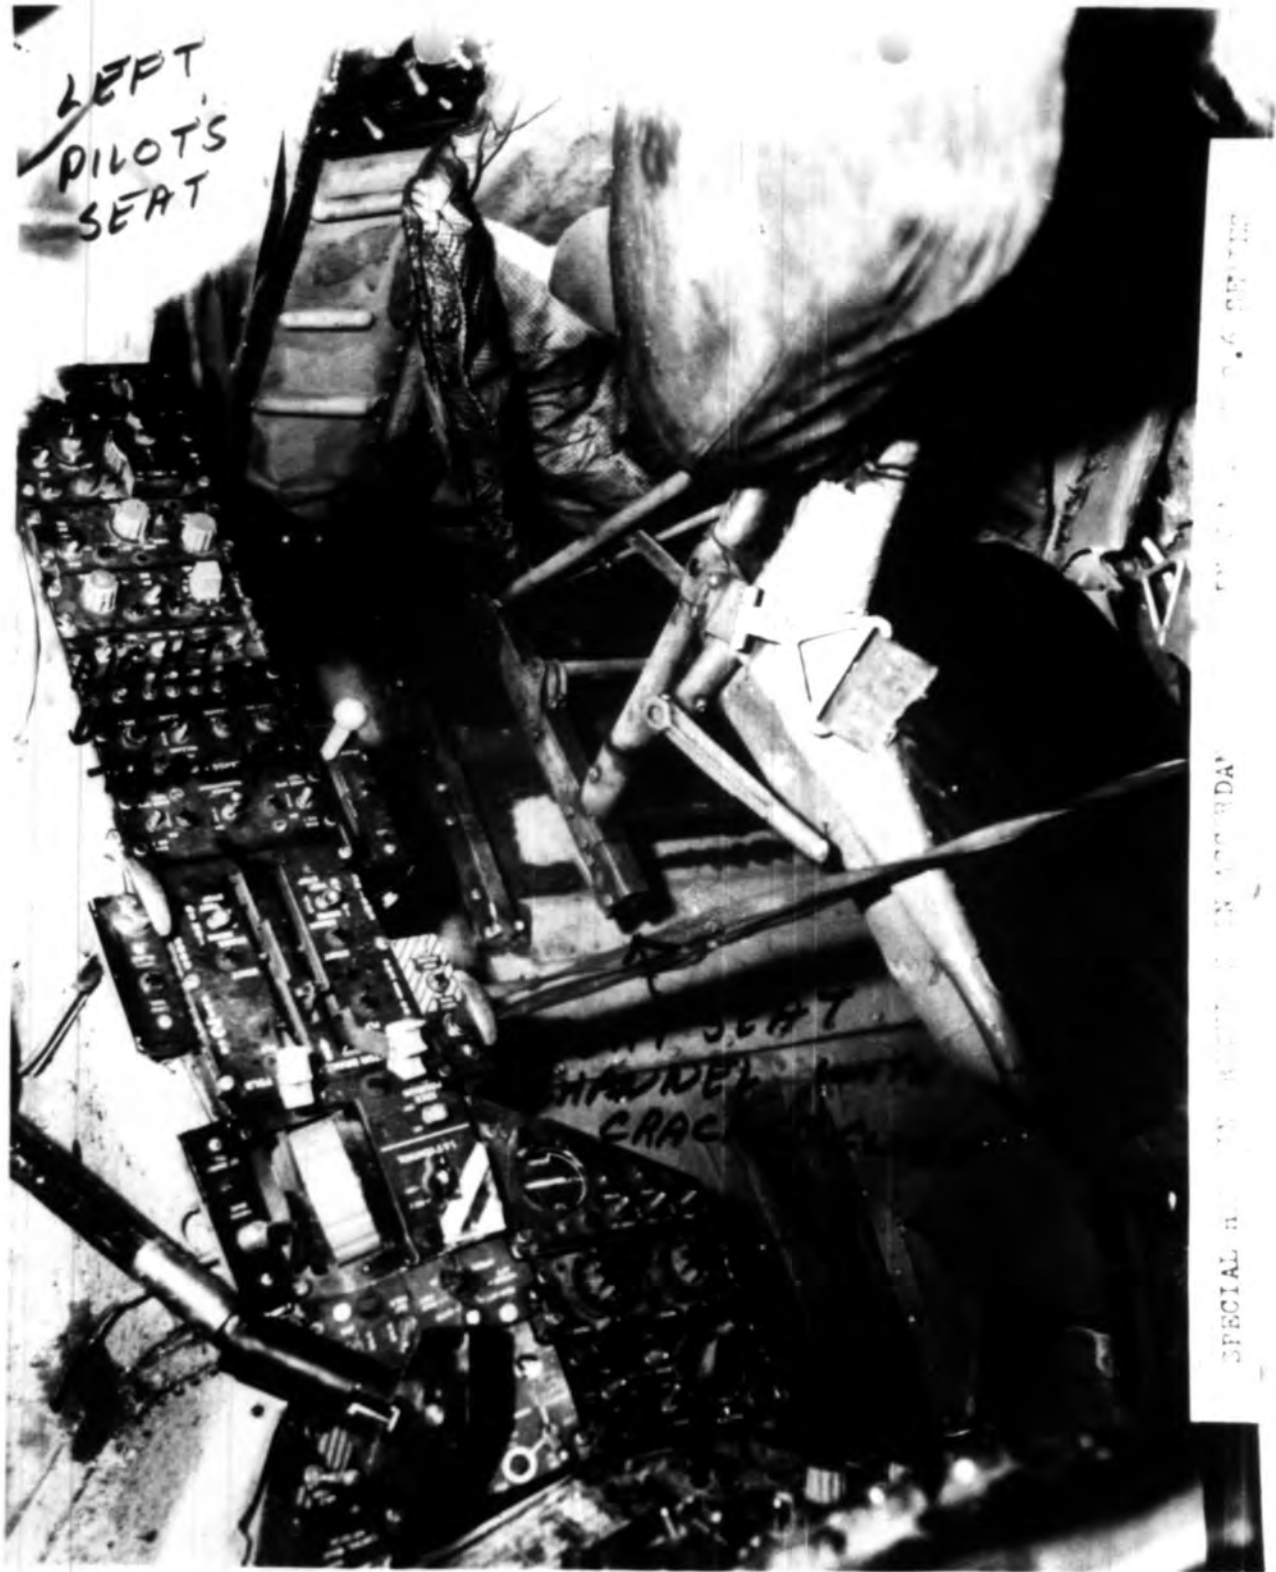
LEFT SEAT
CRACKED

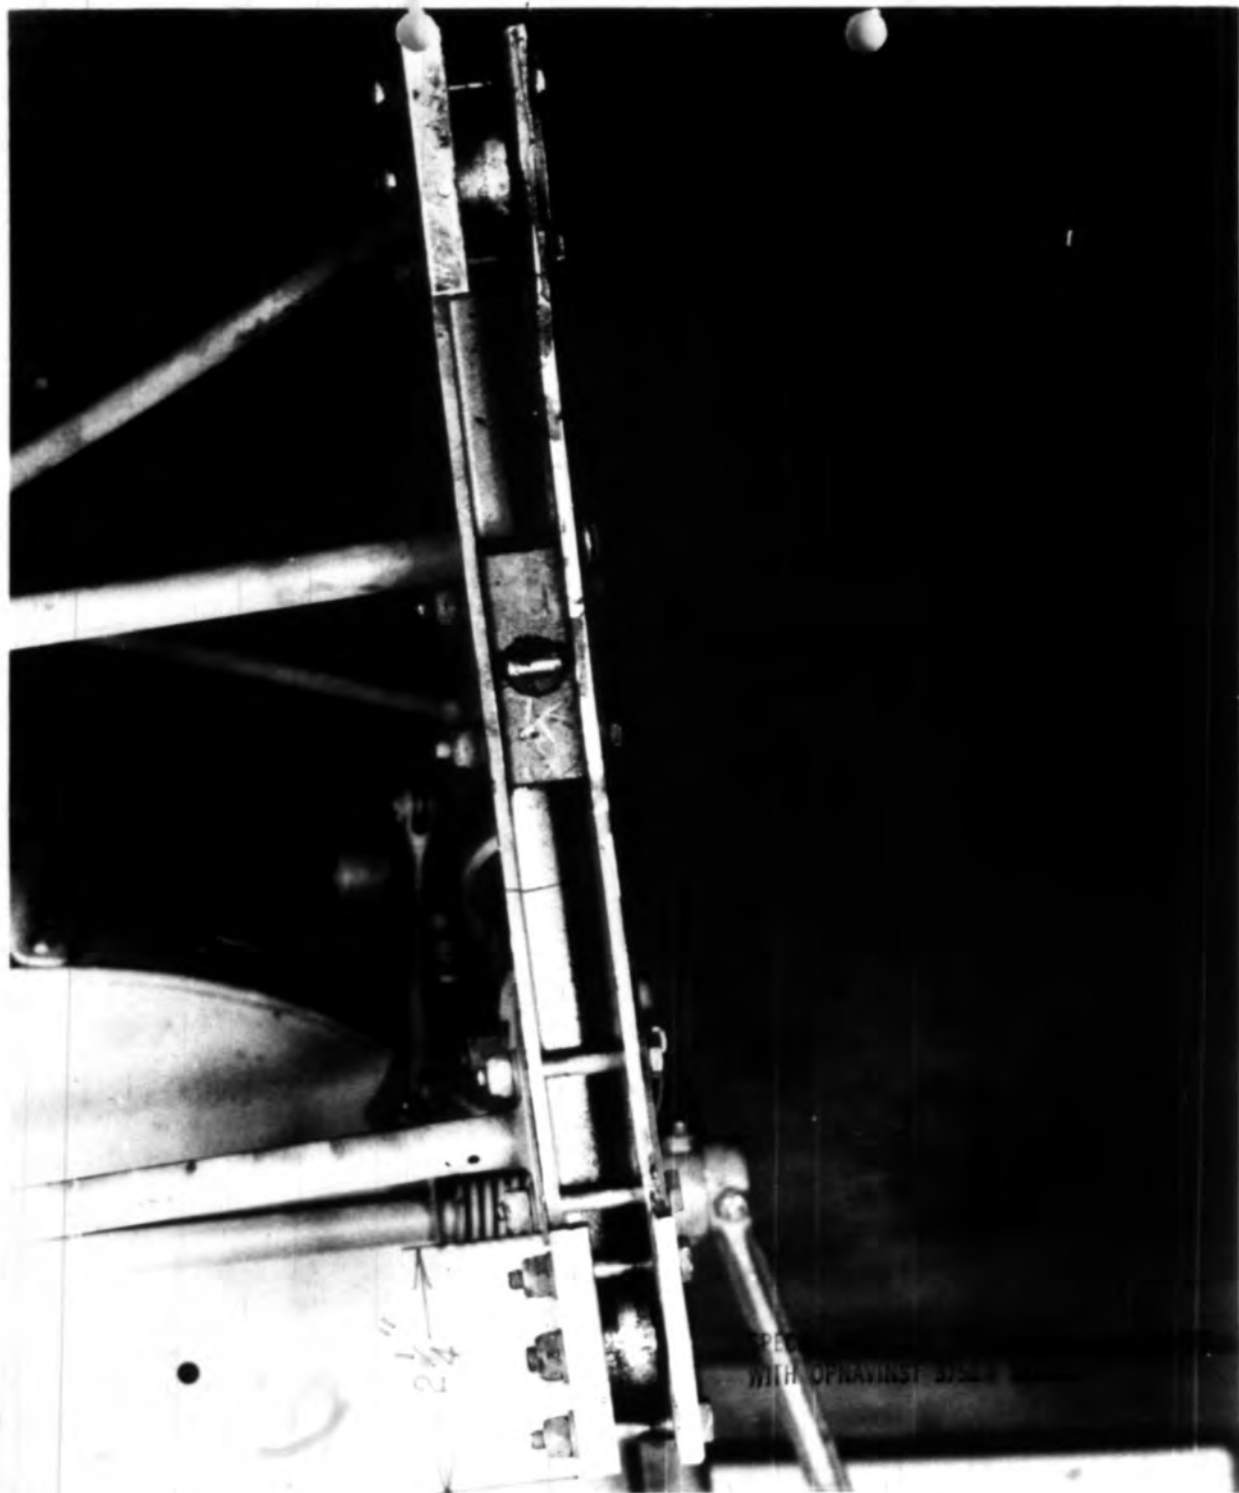
RIGHT SEAT, RIGHT HAND CHANNEL ASSEMBLY (NOTE GRIPPING
FEET ON BOTH ENDS OF ASSEMBLY) ENCLOSURE (12a)

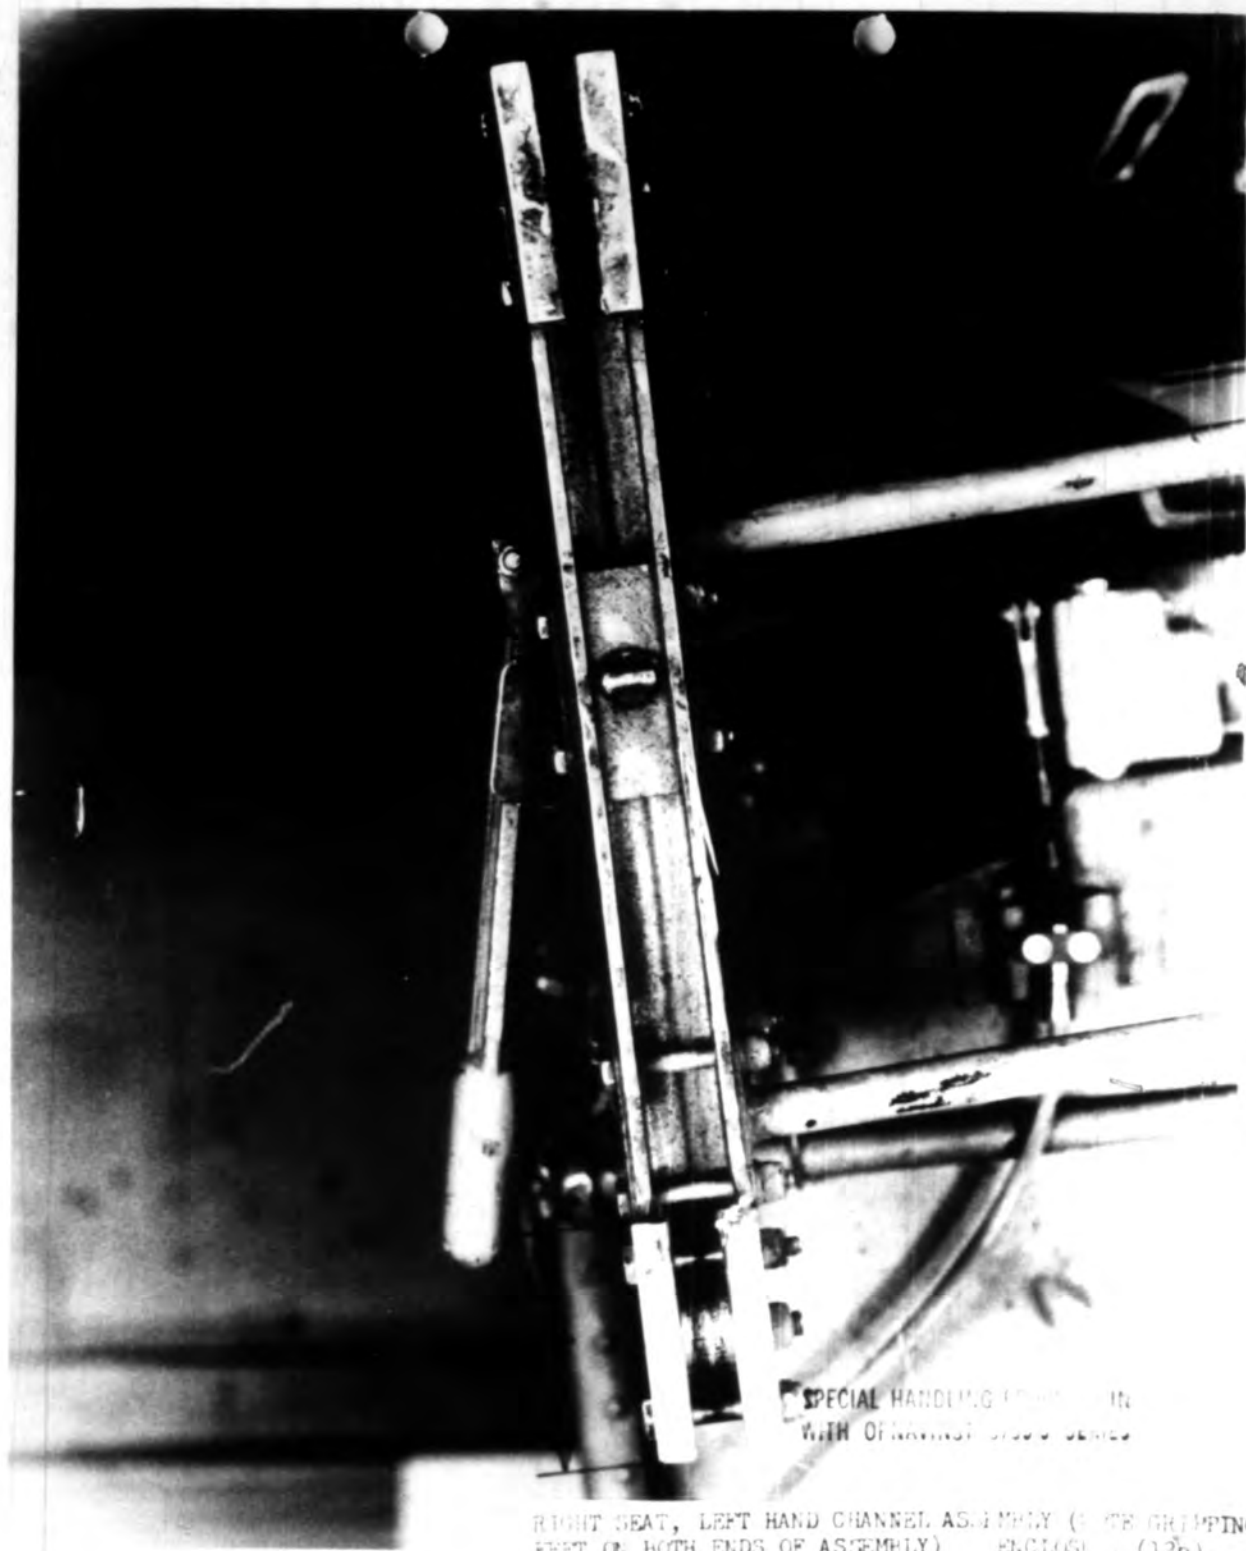
RIGHT SEAT, LEFT HAND CHANNEL ASSEMBLY (SEE GRIPPING
FEET ON BOTH ENDS OF ASSEMBLY) ENCLOSURE (12b)
